ATTACHMENT 2

PHOTO LOG OF GEOLOGIC CONTACTS

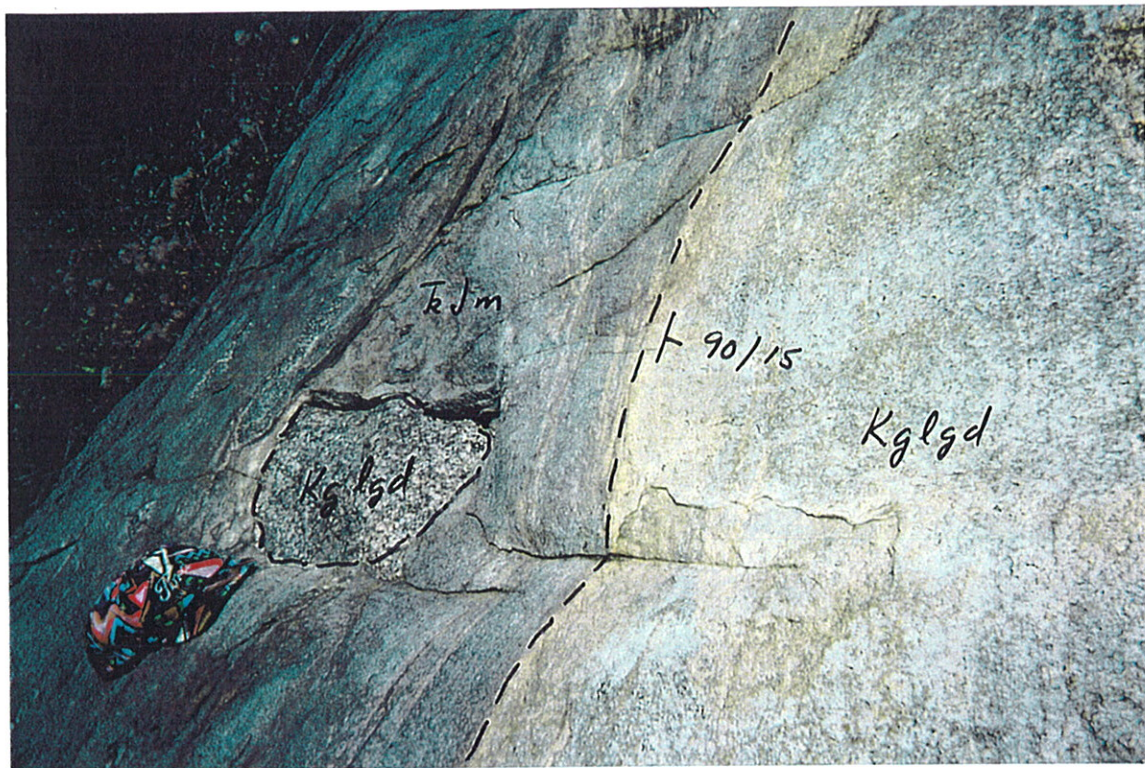
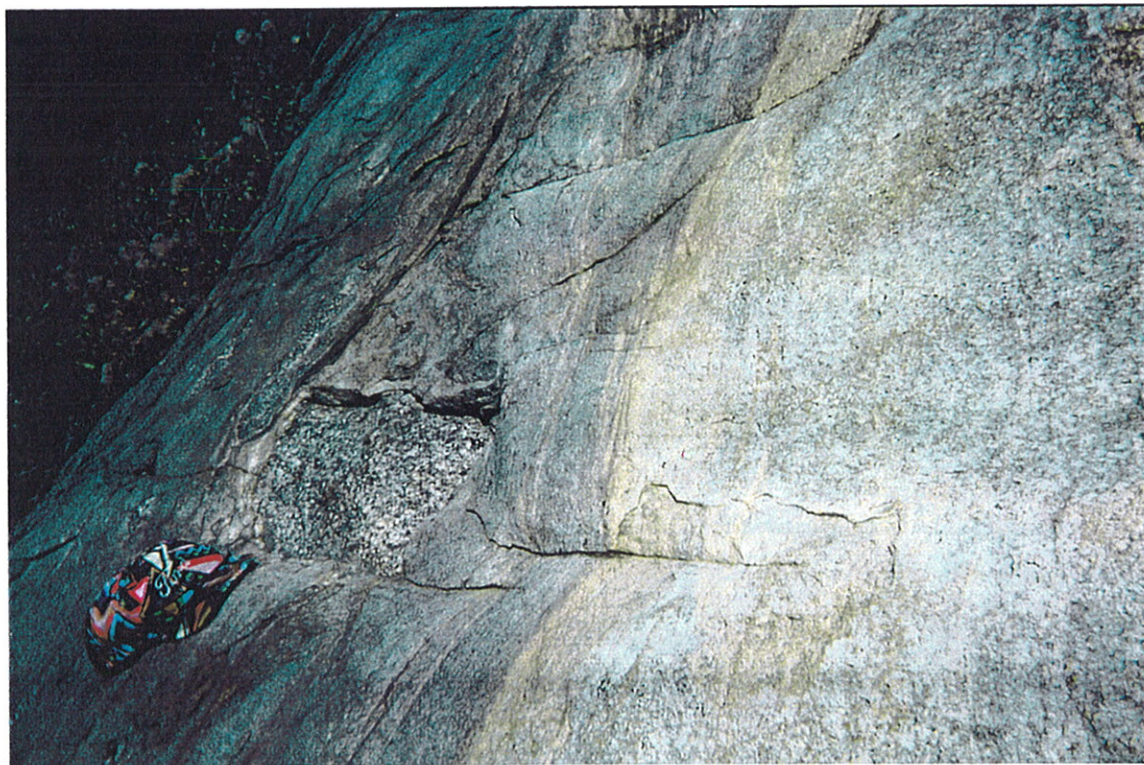
Figure 2. Contact between the leucogranodiorite (Kglgd) and the amphibolites of the metamorphic wedge (Tjm). Note that even though the contact is planar at this scale, it is not brecciated (hence, it is not a fault). In addition, notice the apophysis of leucogranodiorite "poking" through the amphibolite.

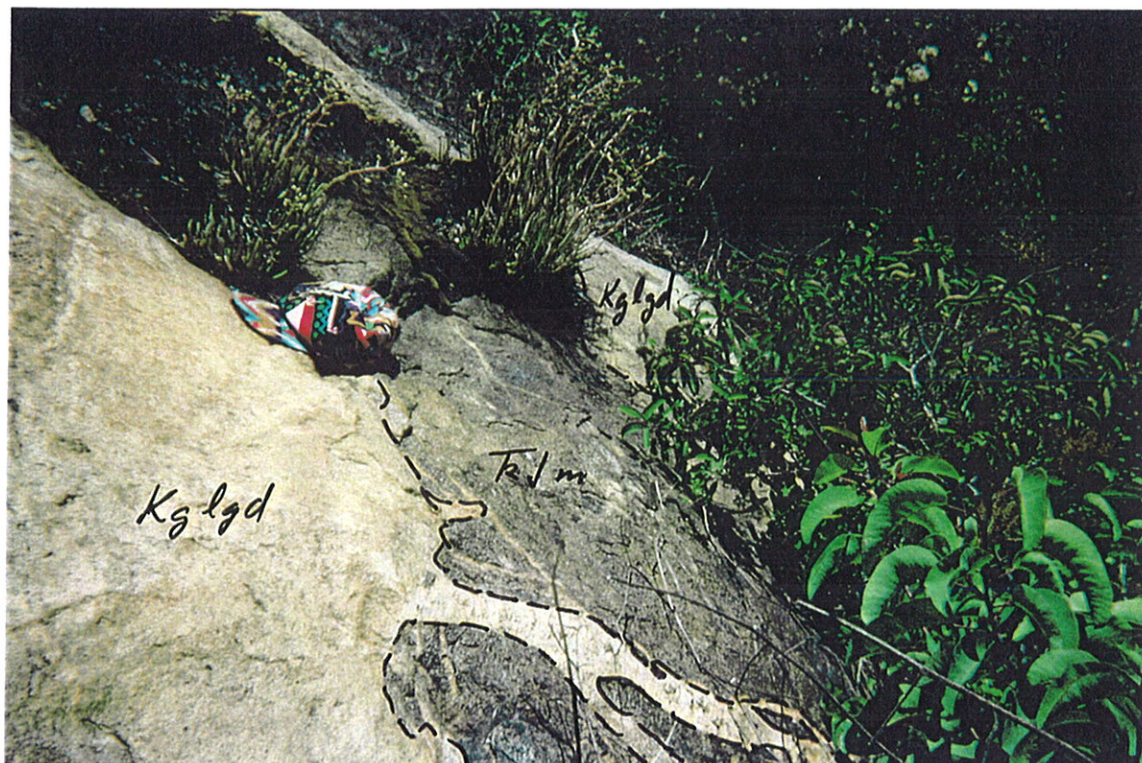
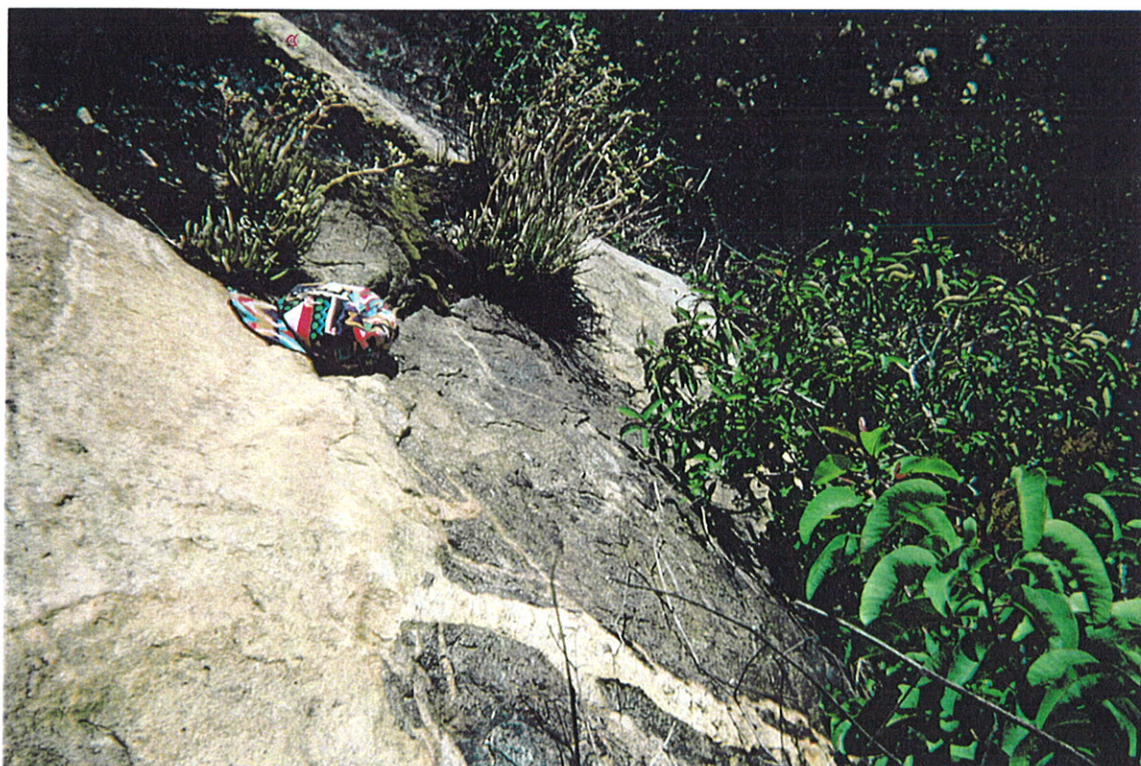
Figure 3. Contact between leucogranodiorite (Kglgd) and the amphibolites of the metamorphic wedge (Tjm). Note pegmatitic dike of Kglgd extending from the contact into the metamorphic unit, which demonstrates that the contact is not a fault.

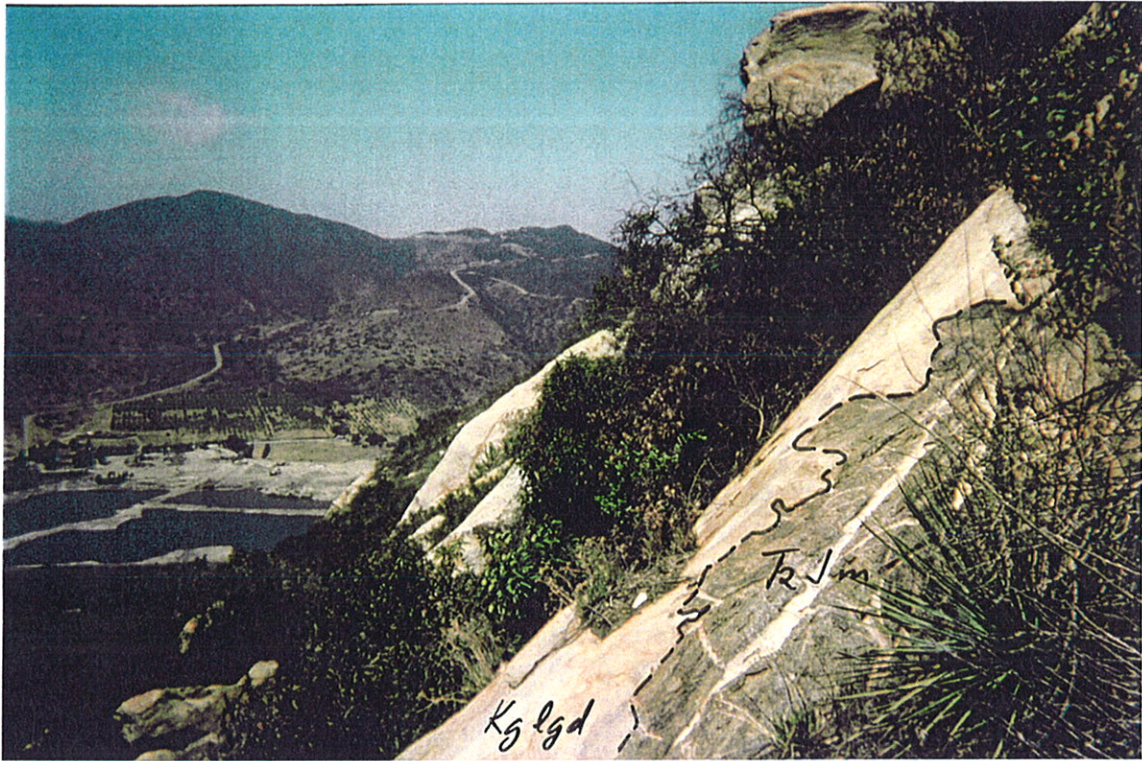
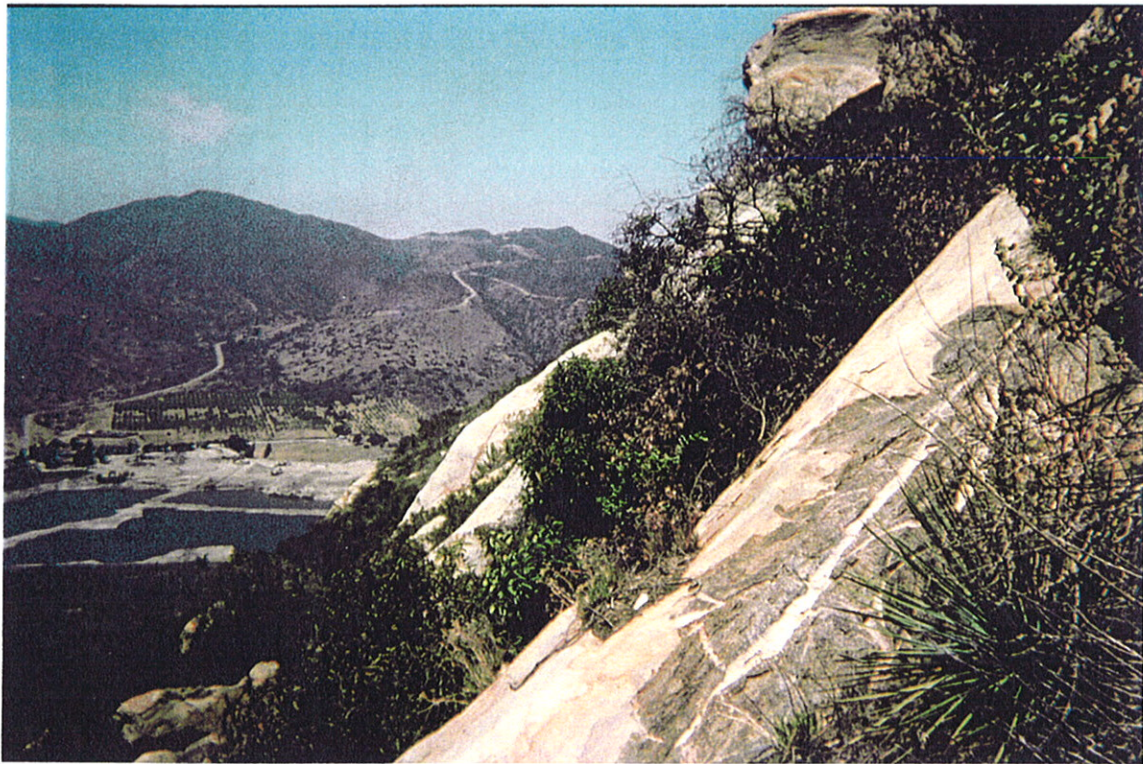
Figure 4. Contact between leucogranodiorite (Kglgd) and the amphibolites of the metamorphic wedge (Tjlm). Note that the contact is not planar, and hence not a fault. Note also that the contact could not be reasonably projected to the right of the ponds because of the outcrop of leucogranodiorite in the second plane.

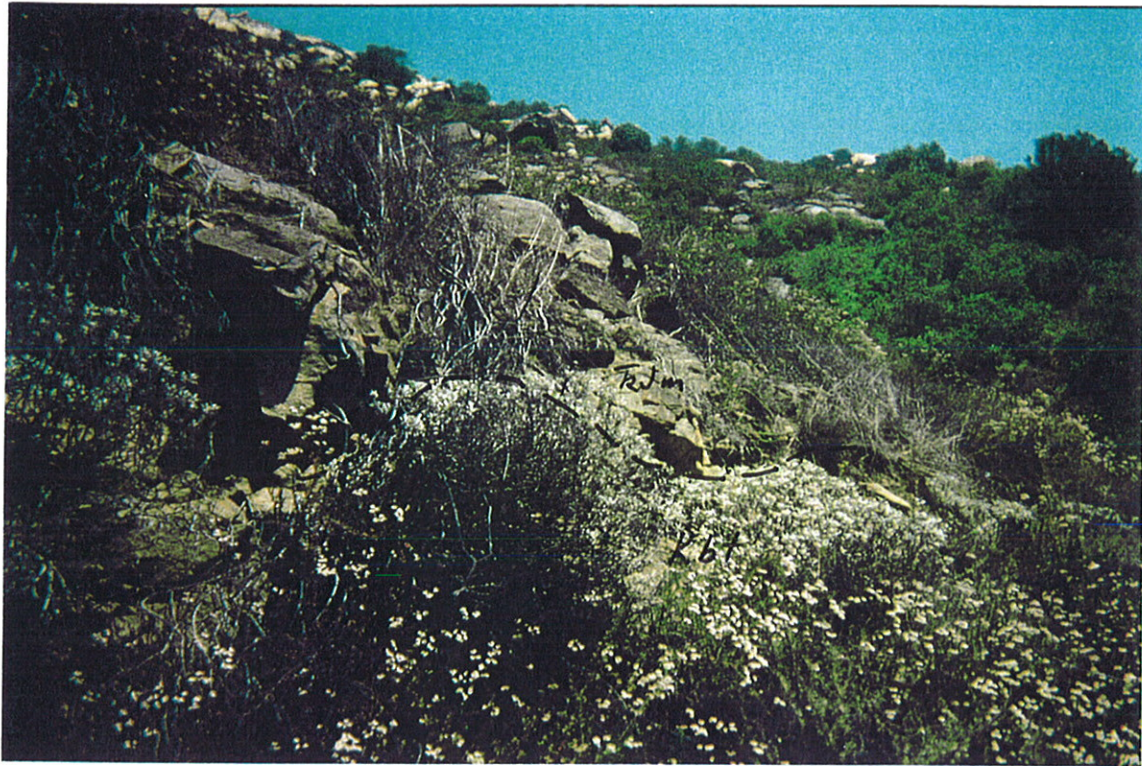
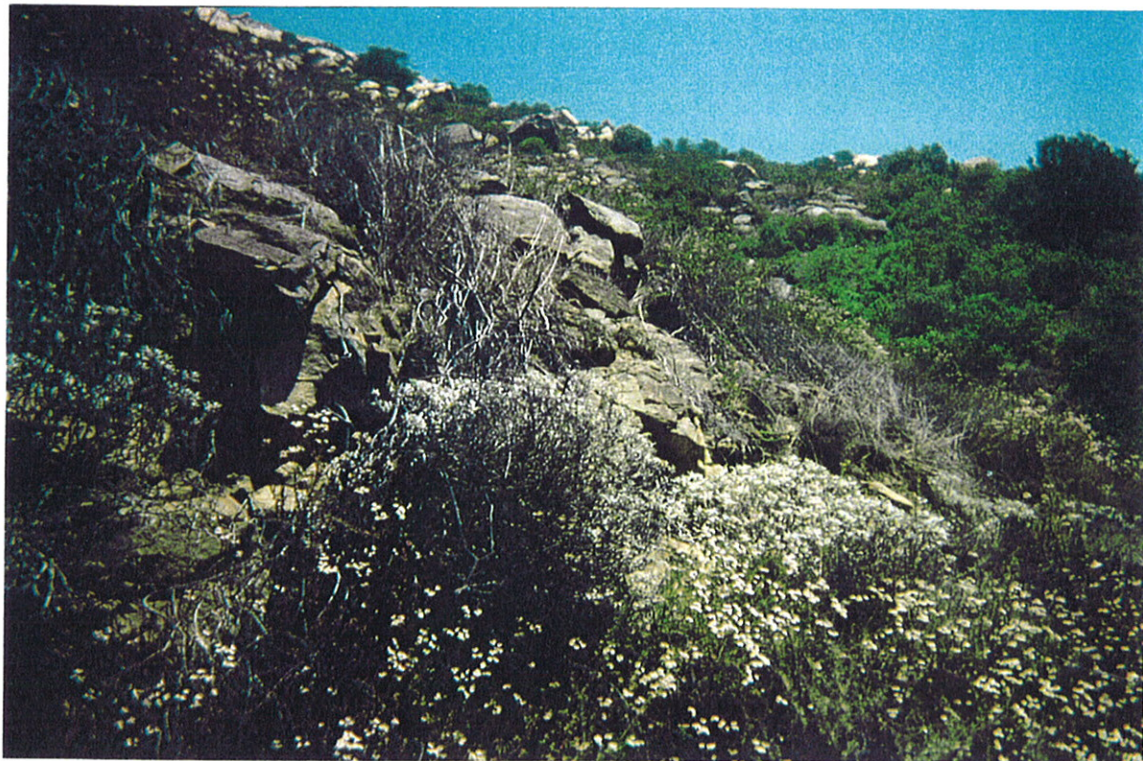
Figure 5. Contact between the tonalite (Kbt) and the amphibolites of the metamorphic wedge (Tjm). Note the irregular nature of the contact, which demonstrates that the contact is not a fault.

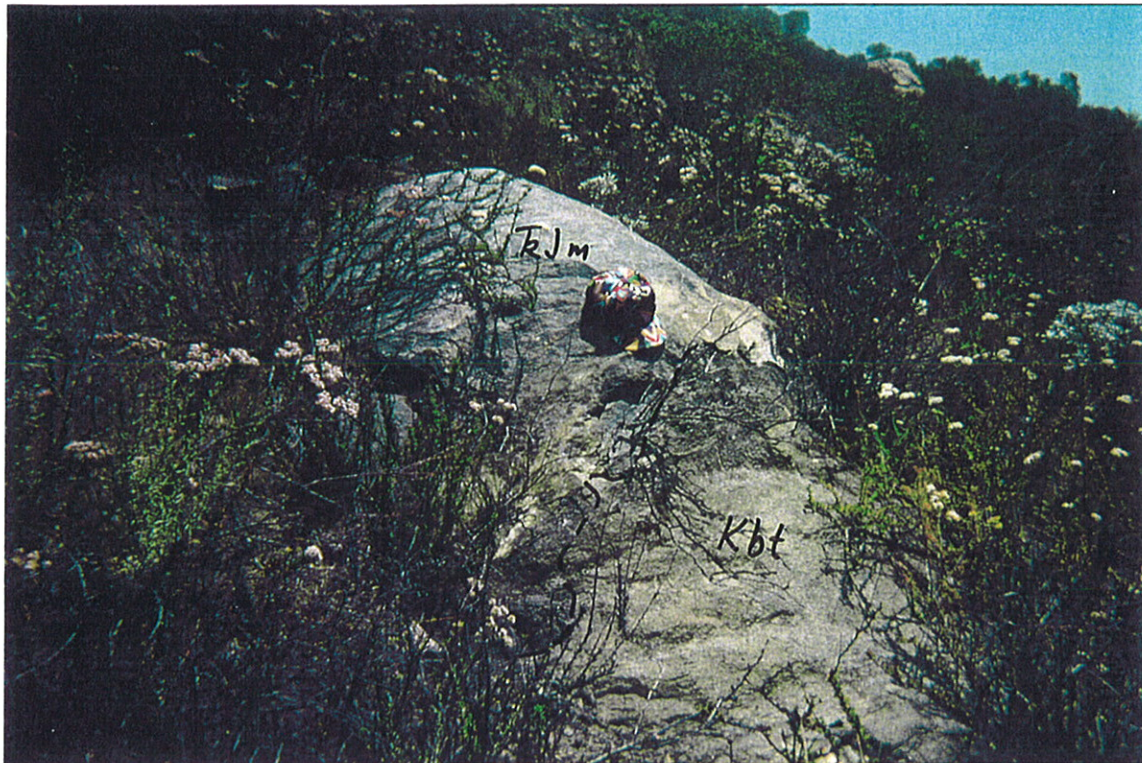
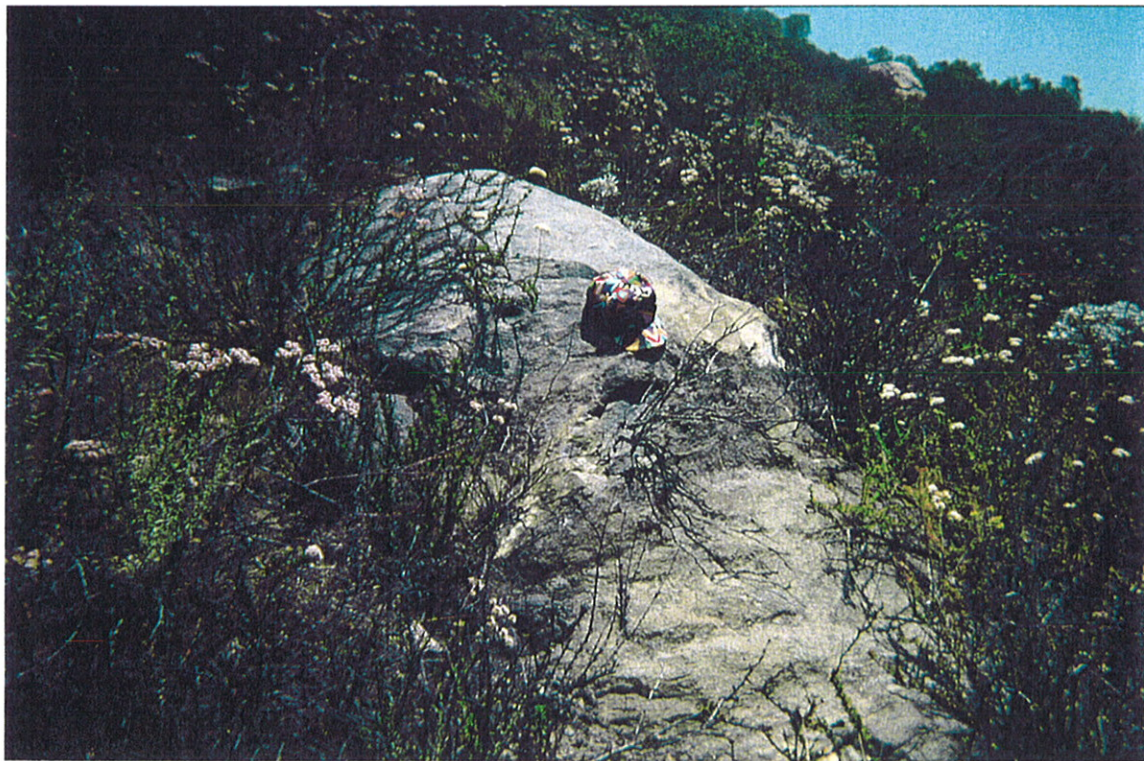
Figure 6. Contact between the tonalite (Kbt) and the amphibolites of the metamorphic wedge (Tjm). Note the irregular, intricate nature of the contact, which demonstrates that the contact is not a fault.

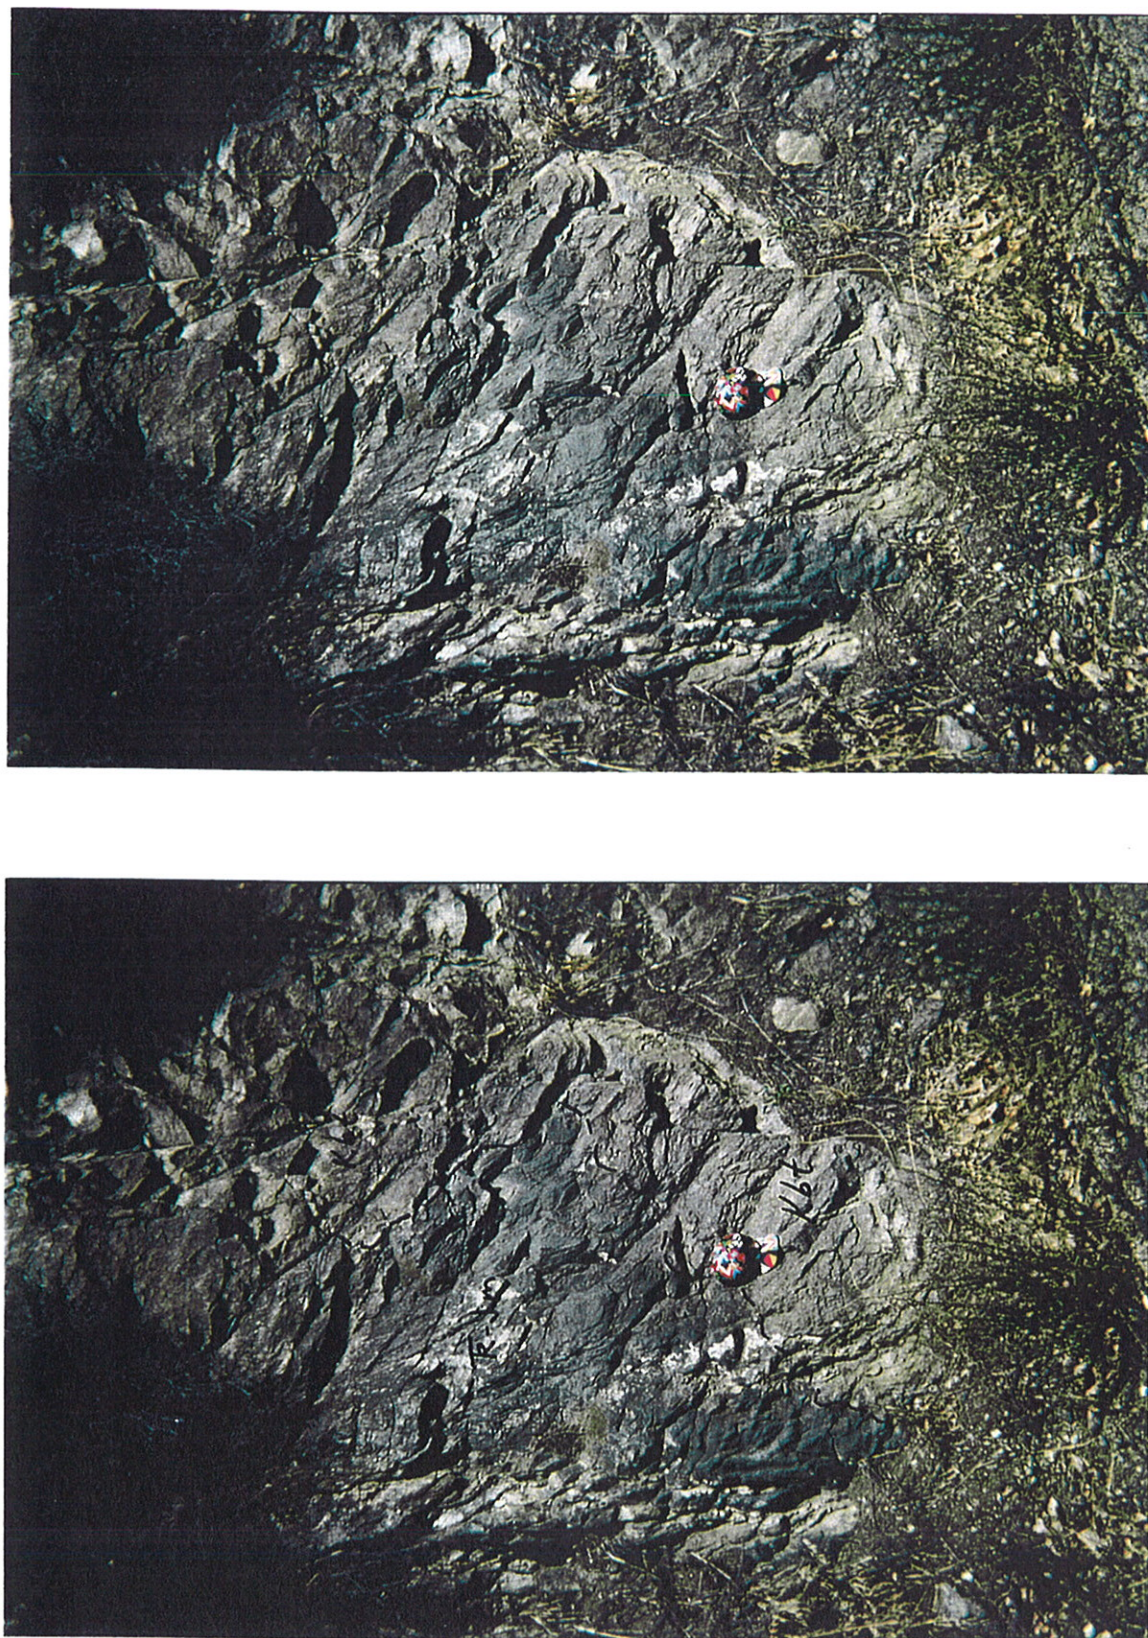
Figure 7. Contact between the tonalite (Kbt) and the amphibolites of the metamorphic wedge (Tjm). Note the irregular, intricate nature of the contact, which demonstrates that the contact is not a fault.

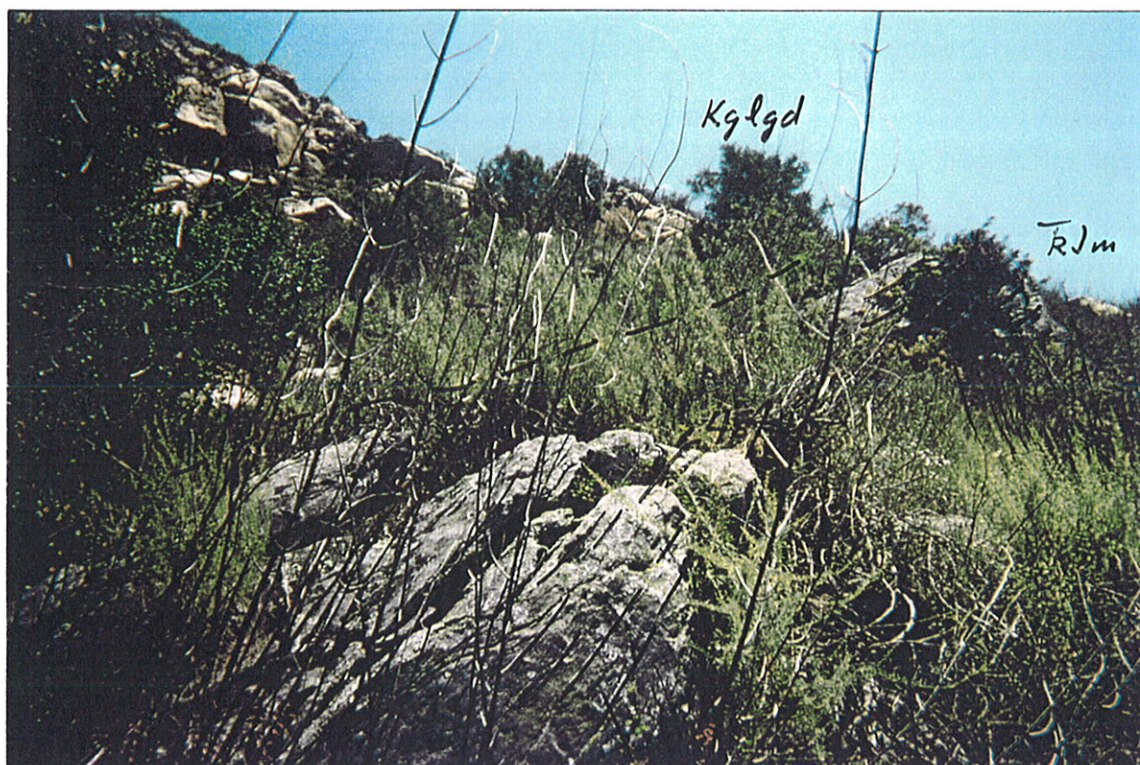
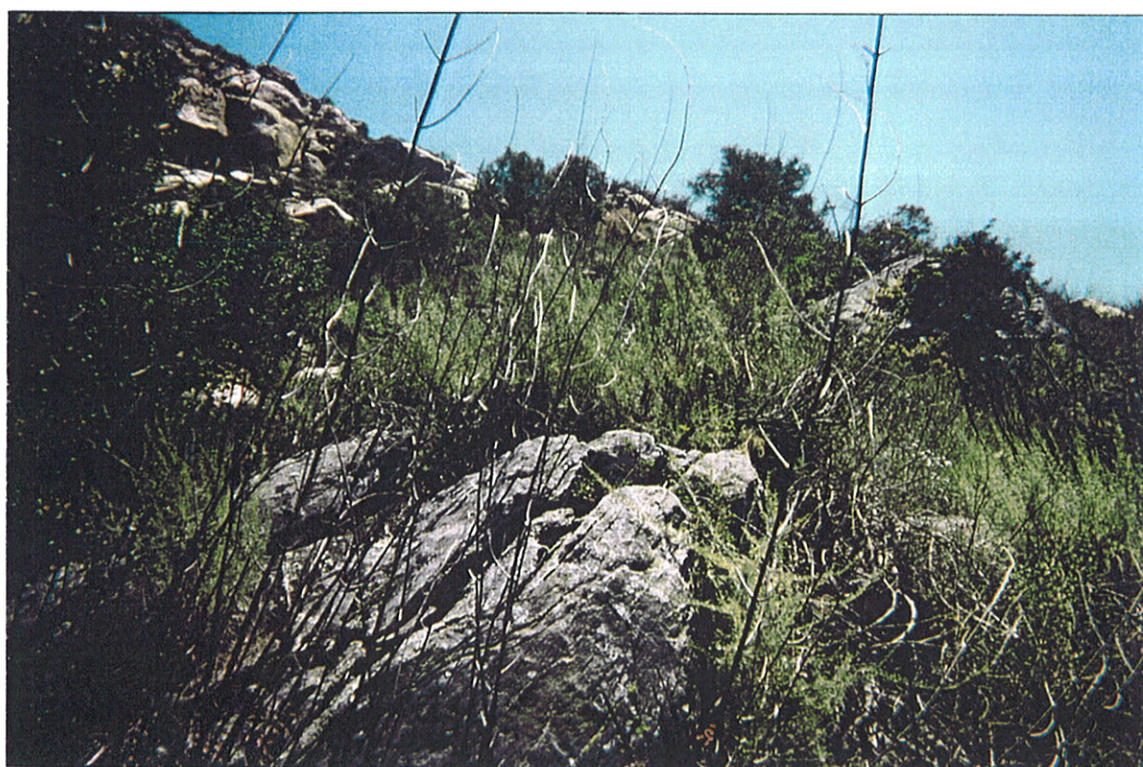
Figure 8. Migmatitic banding in the amphibolites of the metamorphic wedge (Tjm). Note the outcrops of leucogranodiorite (Kglgd) in the upper left, and the fact that banding dips into the slope. Mineralogical banding does not create foliation planes in the rock.

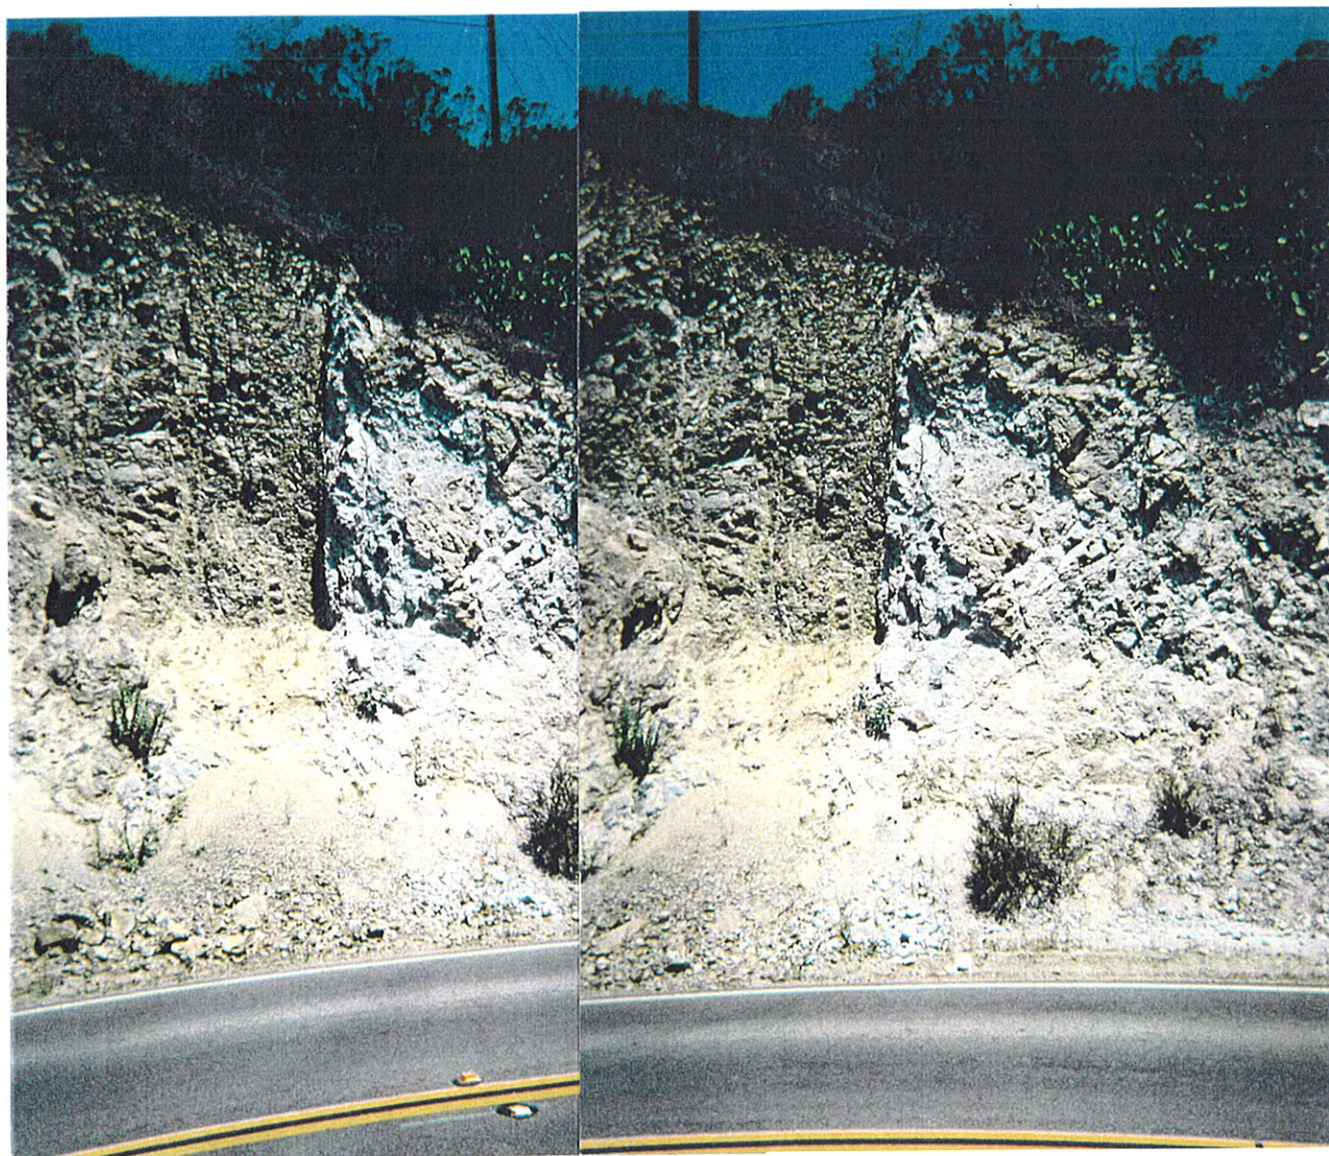
Figure 10. Stereopair of the contact between weathered, vertically-fractured gabbro on the left, and the intrusive gabbroic breccia on the right.

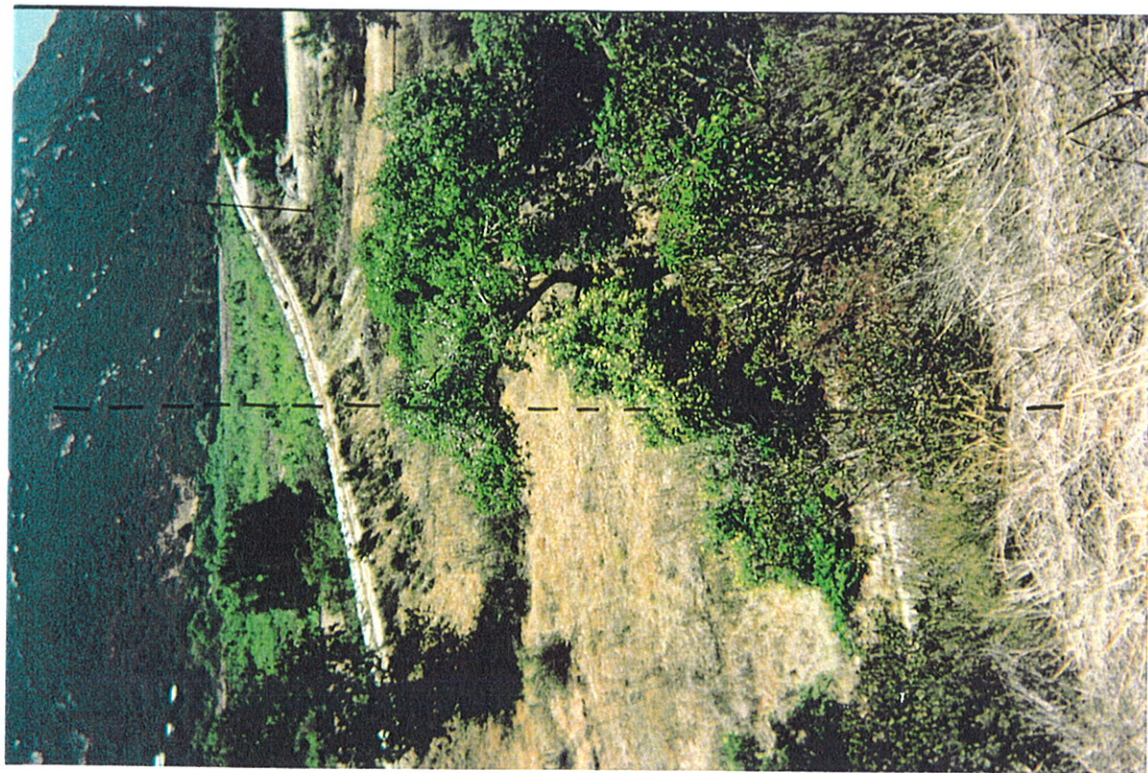
Figure 11. Direction in which the contact of the intrusive breccia would project toward Gregory Mountain.

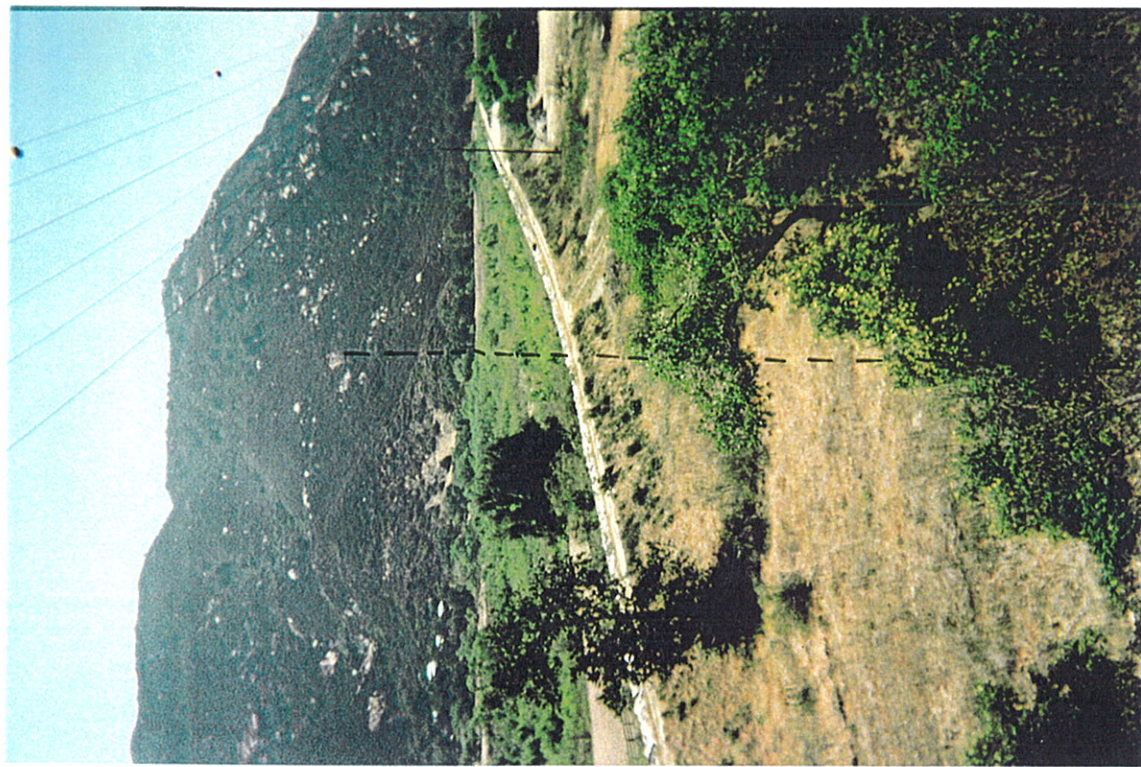
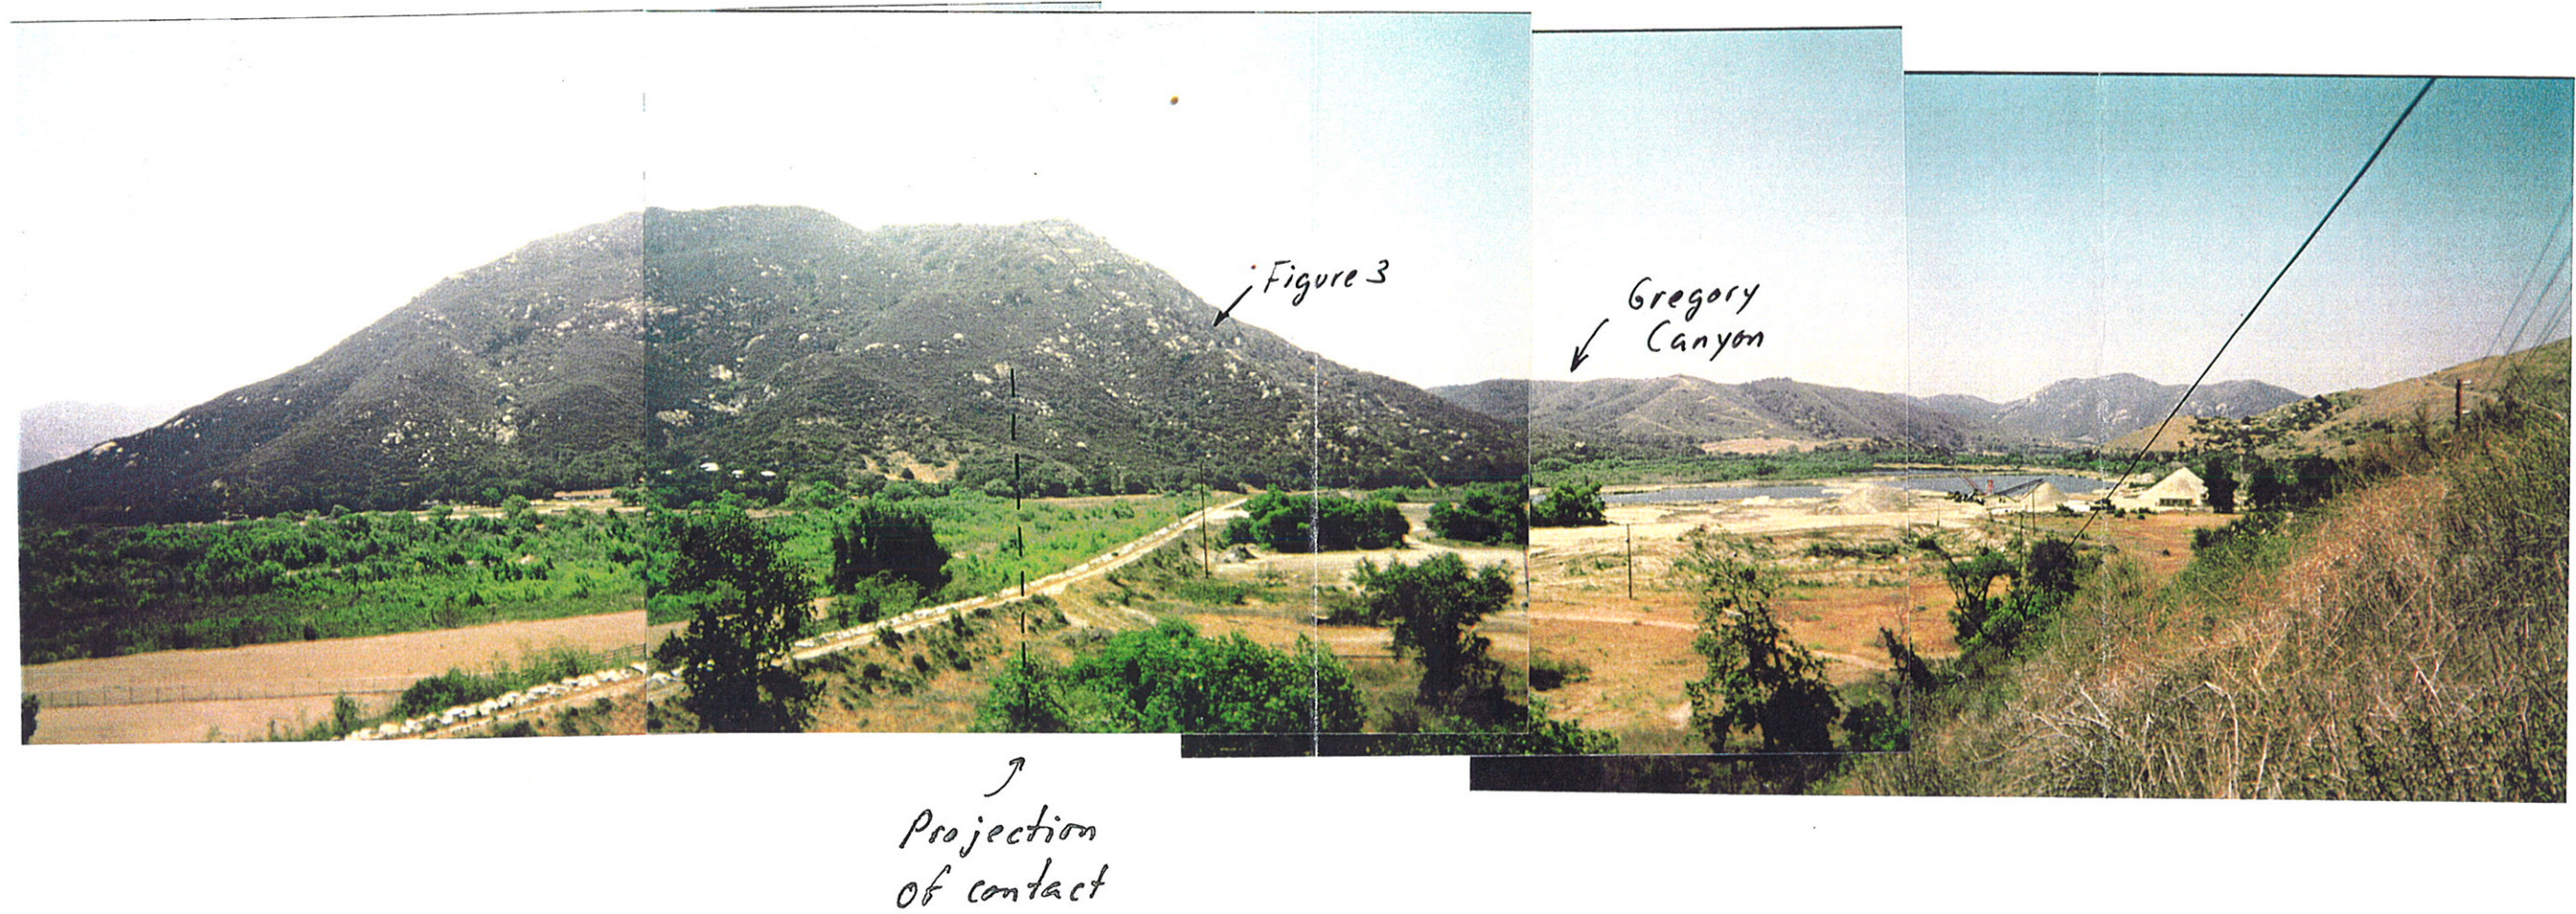
Figure 12. Photo montage showing the considerable distance between the projection of the contact of the intrusive breccia and Gregory Canyon itself.
